A FORENSIC ENGINEERING ANALYSIS OF PEDESTRIAN TRIPS AND FALLS SUBJECT TO WHEELSTOPS IN PARKING LOTS

by Dr. Gary A. Presswood, ScD, PE (NAFE 439)
NAFE 2019 Winter Conference Orlando, FL
Presentation January 5, 2019

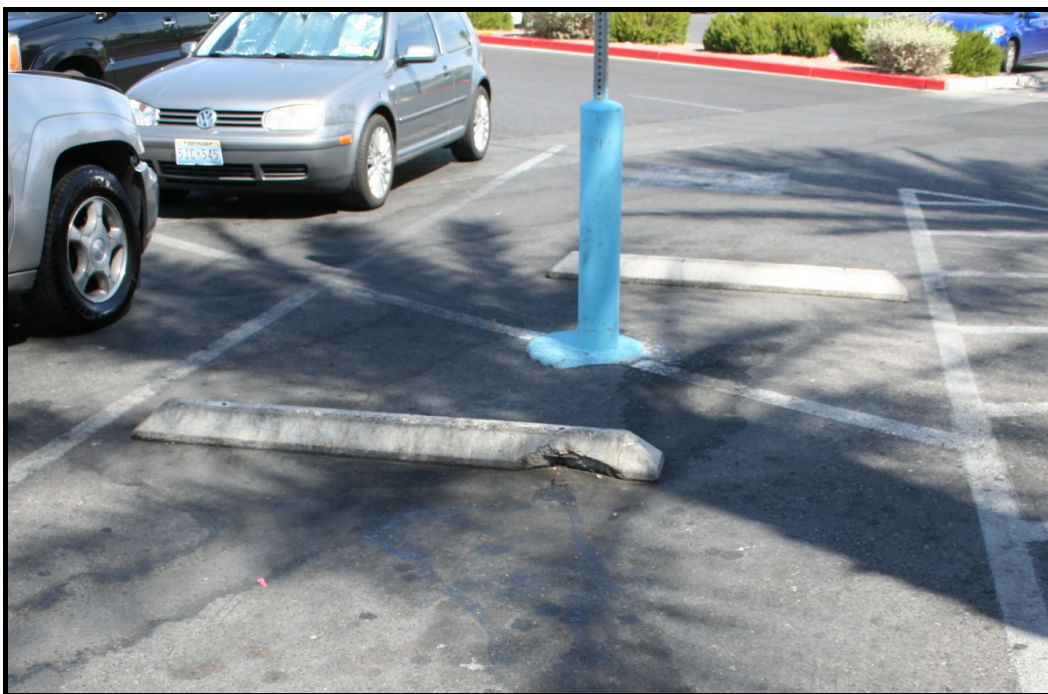
However, the concrete wheelstop often develops cracks at or near the location of rebar (or spikes) where in time the concrete eventually fails and leaves debris and on occasion, exposed rebar, both recognized tripping hazards. Essentially, as a vehicle's tire impacts the wheelstop near the rebar, the force results in a material stress of which the concrete eventually fails, initially leaving cracks wherein the concrete ultimately breaks leaving debris and often, exposed rebar. Initially cracks appear within the concrete in the area of rebar (or spikes). The cracks typically expand upon receiving additional "bumps" from the wheels of parked cars and eventually, the concrete fractures, leaving debris such as rocks and remnants of concrete, in the area of pedestrian traffic which results in additional sources of trip and fall hazards. (Note Photo Ex. 1.)

Photo Ex. 1: Note fractured wheelstop.

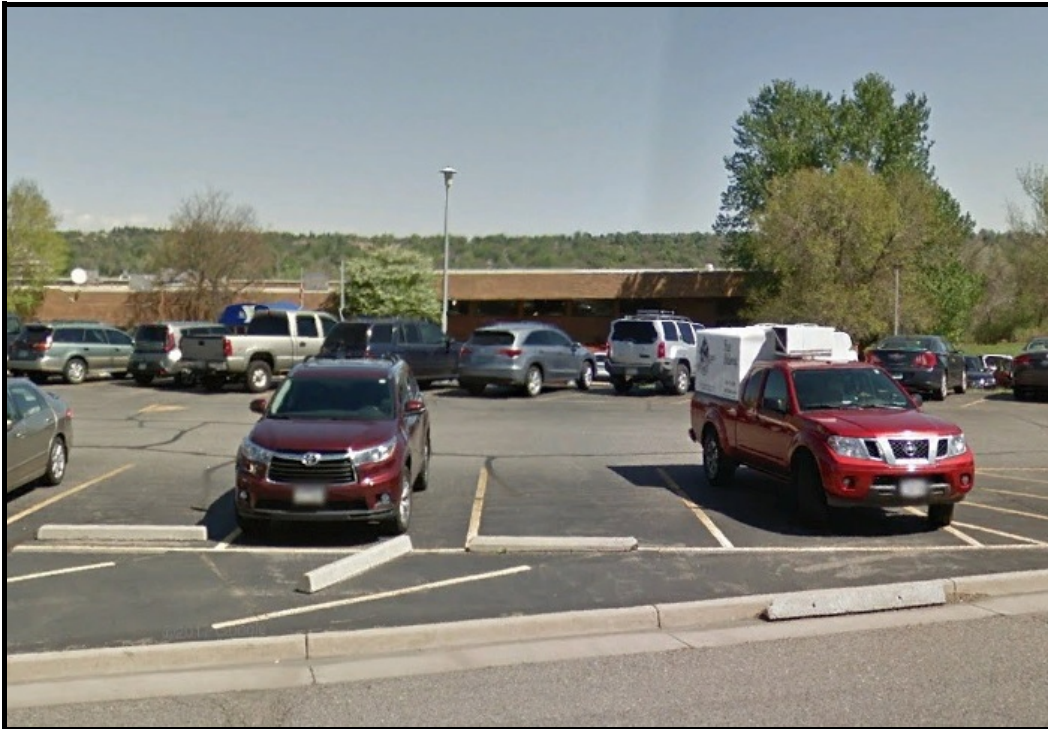
Wheelstops within parking lots are also subject to impact by street sweepers, snow removal machinery, and delivery vehicles or by other means which, when wheelstops are not properly secured, they are occasionally displaced. This is often a common effect of snow removal in locations where the wheelstop boundaries are often not seen. (See Photo Ex.2.)

Photo Ex. 2: Note displaced wheelstops.

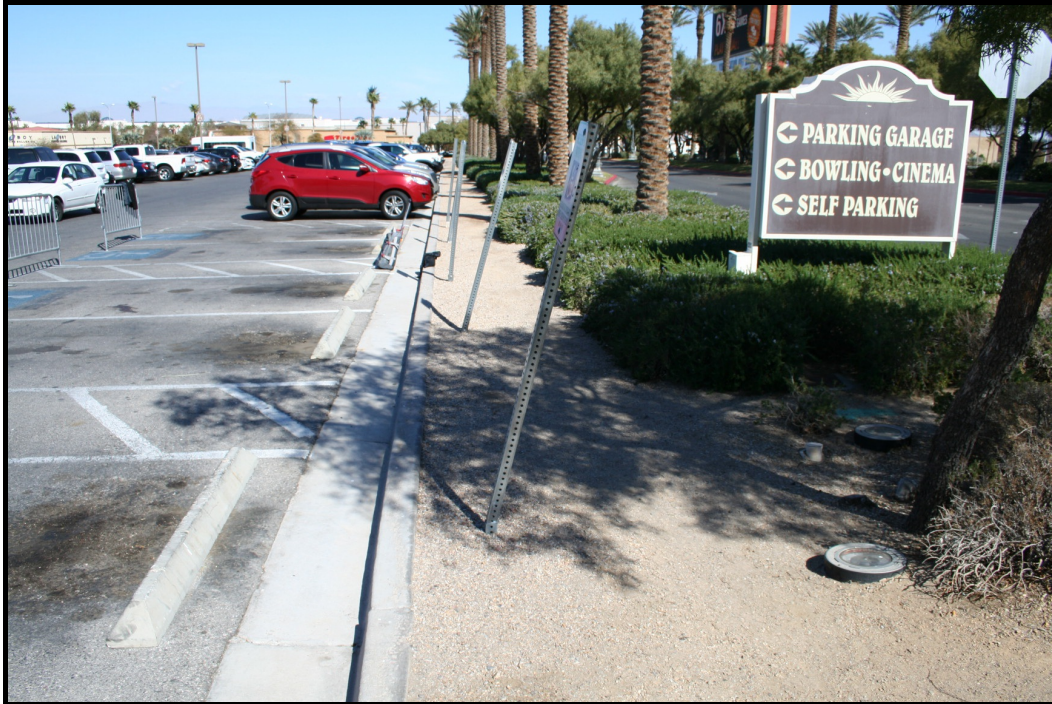
A major hotel and recreational facility experienced civil litigation regarding a trip and fall wherein an elderly lady stepped off a raised curb (from an established pathway leading to her parked car) and onto an asphalt parking lot. She then proceed to walk toward her parked vehicle located within an accessible parking stall. As the legal discovery process went on, it was revealed by management personnel that wheelstops were initially installed to protect signposts supporting ADA-required accessibility sign placed atop the signposts. Evidence of the failure to protect the signposts are presented herein as Photo Ex. 3.

Photo Ex. 3. Note leaning sign posts.

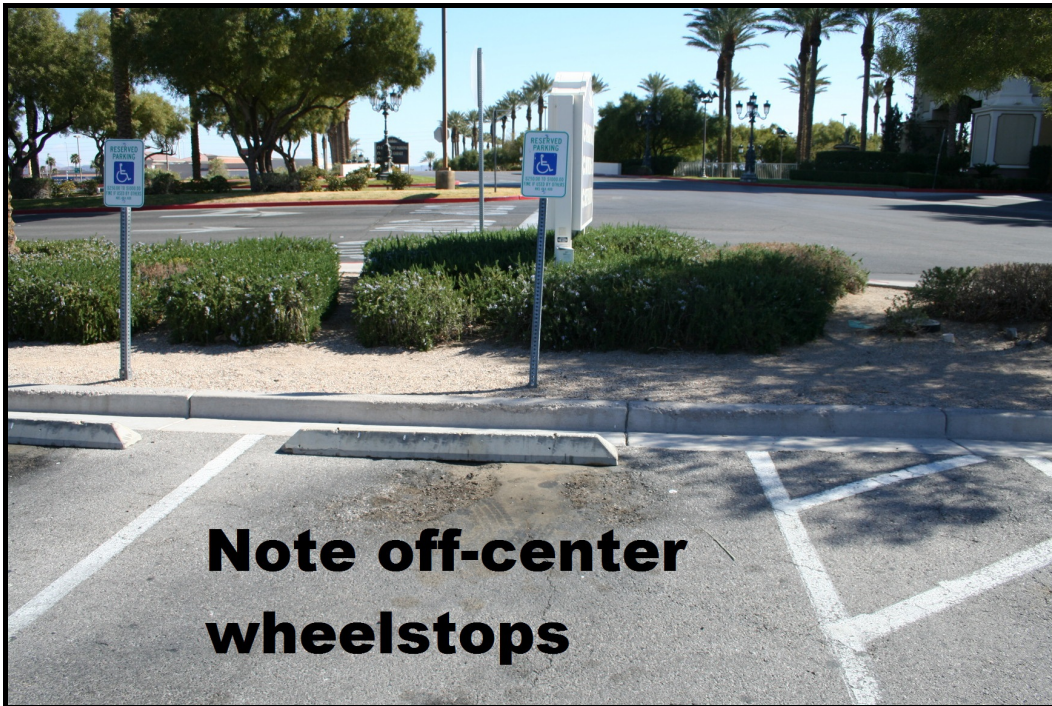
In addition, a frontal view of the same location reveals the mis-placed wheelstops, placed to one side of the parking stall and near an expected pedestrian pathway where the elderly lady tripped over a wheelstop and sustained significant injuries (see Photo Ex. 4).

Photo Ex. 4. Off-center wheelstops created tripping hazard.

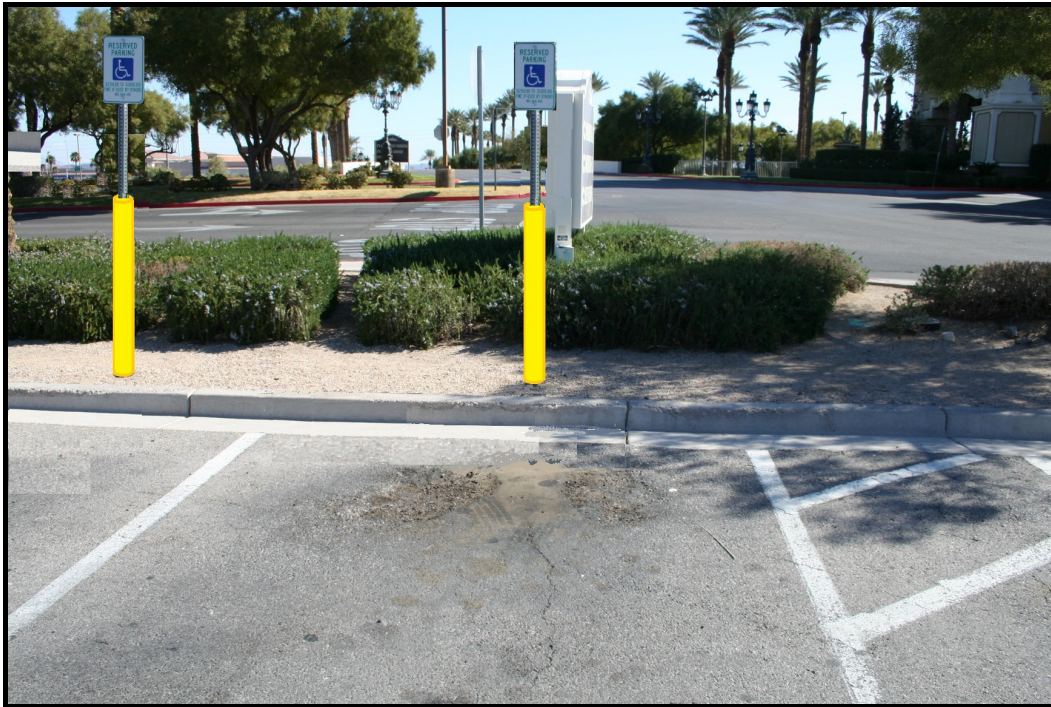
Photo Ex. 5. Wheelstops removed and signs placed atop concrete-filled steel bollards.

As stated in ASTM F1637, bollards are a reasonable and preferred alternative to wheelstops. Bollards will stop an errant vehicle where wheelstops and sign posts will not. Since Federal (ADA) and many local standards for parking lot design, require accessible signage to be placed at certain heights (5' to the bottom of signs required by the ADA), and in the front of accessible parking stalls, the preferred and safe design would include the elimination of wheelstops, and the replacement of concrete-filled steel bollards with the required signage affixed atop the bollard (see Photo Ex. 5).

Finally, a solution was presented (via Windows Paint) which effectively addressed the errors in judgement and settled the civil suit (see Photo Ex. 5).

Wheelstops are hazardous elements when placed within predictable pedestrian paths in parking lots. Such elements are not necessary since the overwhelming number of parking stalls can be delineated solely by painting each parking stall boundary (ref. Photo Ex. 5). The ADA Accessibility Guidelines require that accessible parking stalls (i.e., those for disabled persons), require accessibility signs be placed a minimum of 60" above the surrounding grade to a point at the bottom of the sign. When necessary to assign the restrictive location of accessible parking stalls, signs are often placed atop sign posts which are protected by wheelstops; however, the overhang of vehicles is not a standard dimension resulting in many impacts with the sign posts. Concrete-filled steel bollards are the best alternative to this dilemma and other location where wheelstops are intended.
